State of California
Department of Public Works
Division of Highways
Materials and Research Department

June 21, 1960

AN INVESTIGATION
of the
SUBSURFACE AND SURFACE
DRAINAGE CONDITIONS
on
ROAD I-Men-1-D,E
between
4.1 MI. NORTH OF FORSYTHE CREEK AND RIDGEWOOD SUMMIT

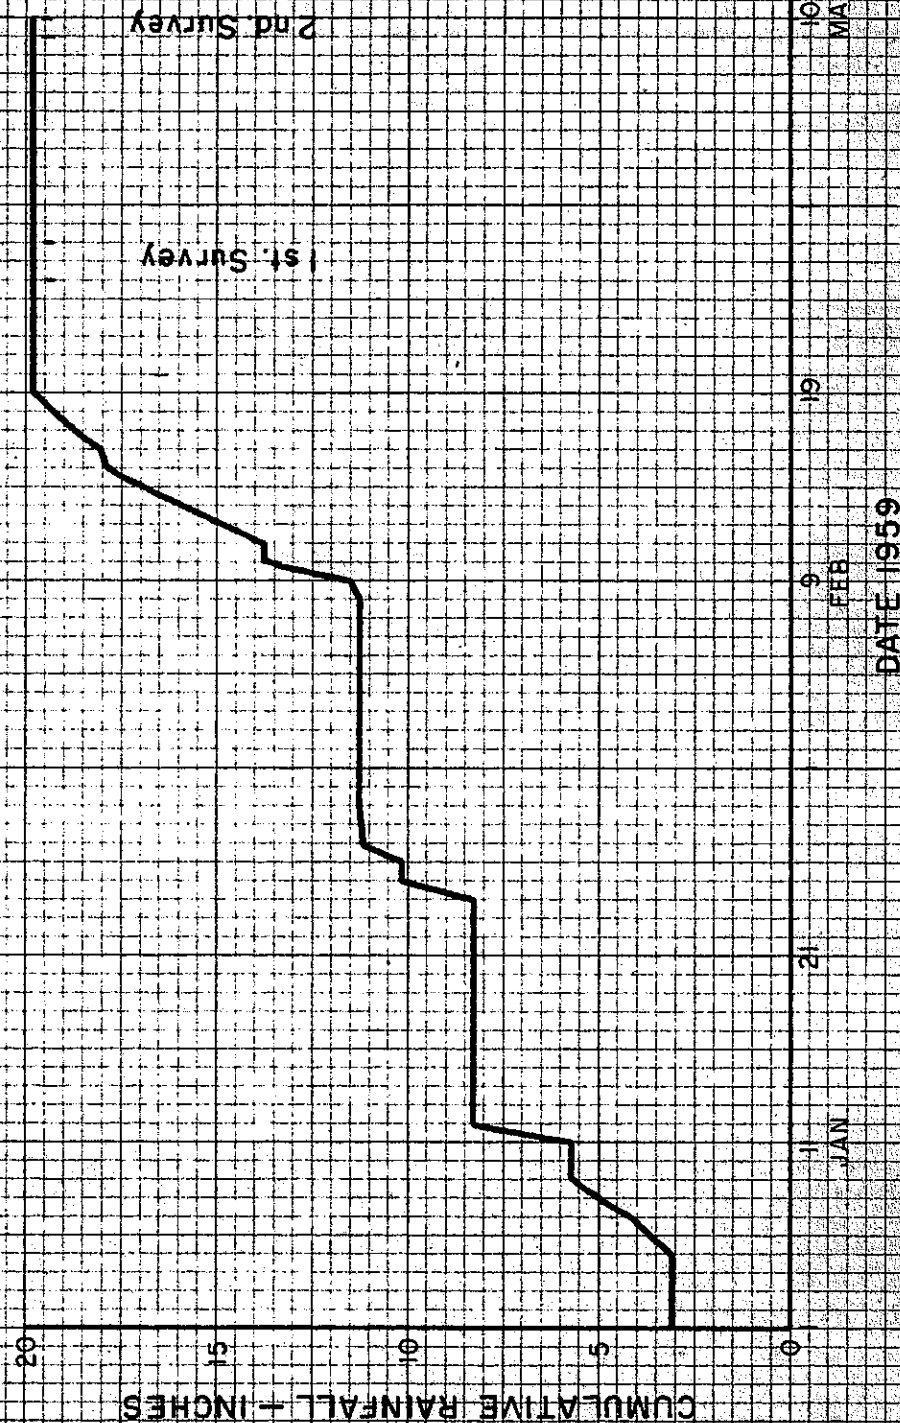
RAINFALL MEASURED AT
WILLITS HOWARD FOREST RANGER STATION
RIDGEWOOD SUMMIT
IT-MEN-1-D,E

The average annual rainfall for the Ridgewood Summit area is fifty inches. Figure No. 1 shows the rainfall for the period January 1, 1959, to March 10, 1959. Most of the rainfall occurs during heavy storms, causing periodic high runoffs. The CMP's and RCB's are of sufficient size to take the runoff. There are two locations, right of Station "D" 209+50 and right of Station "D" 368+50, where the headwall or inlet of the pipe is not properly situated for the large flow that must be handled and some of the water bypasses the headwall and spills out onto the pavement.
